Technical Evaluation of the Gold King Mine Incident

San Juan County, Colorado

U.S. Department of the Interior
Bureau of Reclamation
Technical Service Center
Denver, Colorado

October 2015

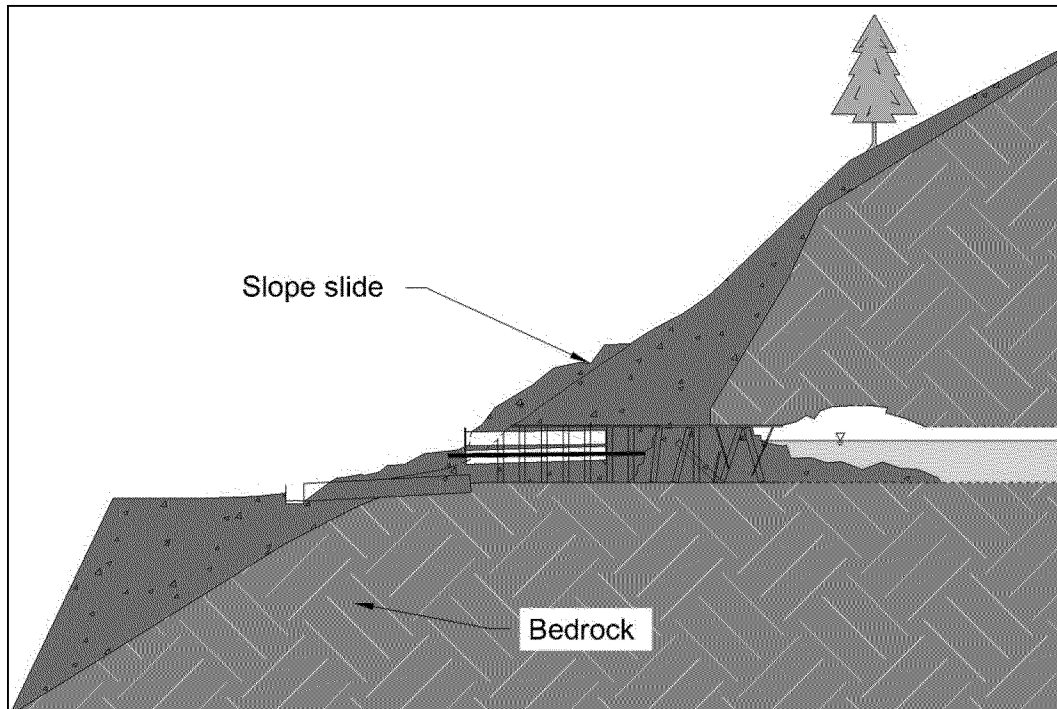
Figure 23.—Cross-section showing the condition of the Gold King Mine Level 7 New Adit in 2014 (water level as assumed by EPA and DRMS), more rock and soil had come down off the slope and were partially blocking the drain, which indicates a lack of maintenance (not to scale).

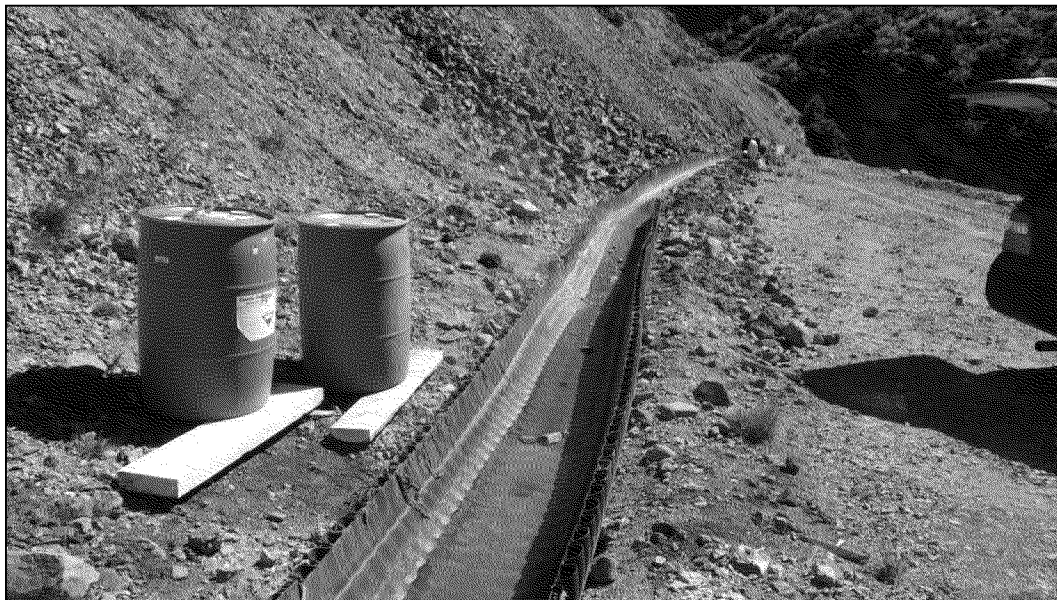
Figure 24.—Photograph showing seepage flow in the half-pipe channel at the Gold King Mine Level 7 New Adit area on September 11, 2014. Flow of approximately 12.6 gpm was recorded (photograph from EPA project files).

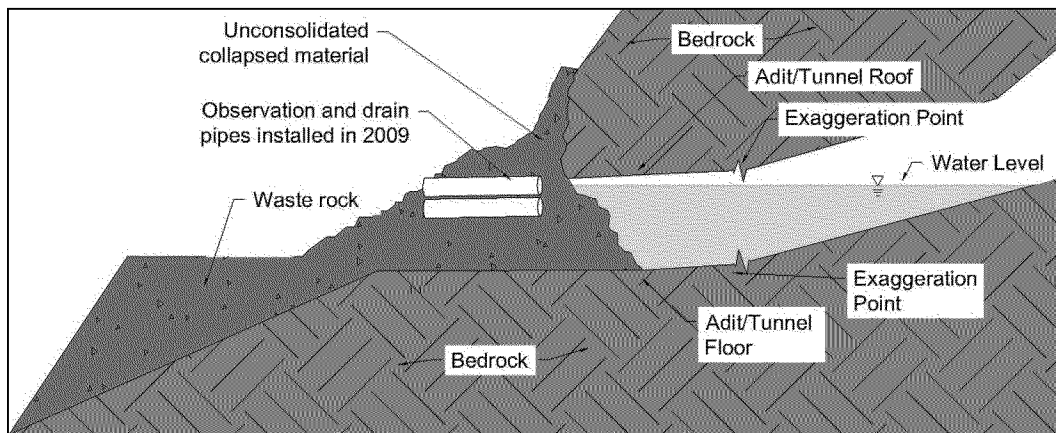
Figure 40.—Cross-section illustration showing the condition of the adit that was assumed by the EPA OSC and the abandoned mine experts from DRMS for use in planning to open the adit (not to scale). The “exaggeration point” means the right side of the drawing has an exaggerated vertical scale in order to show the 1% uphill slope of the adit. If drawn without exaggeration, the uphill slope of the adit would not be obvious on the drawing.

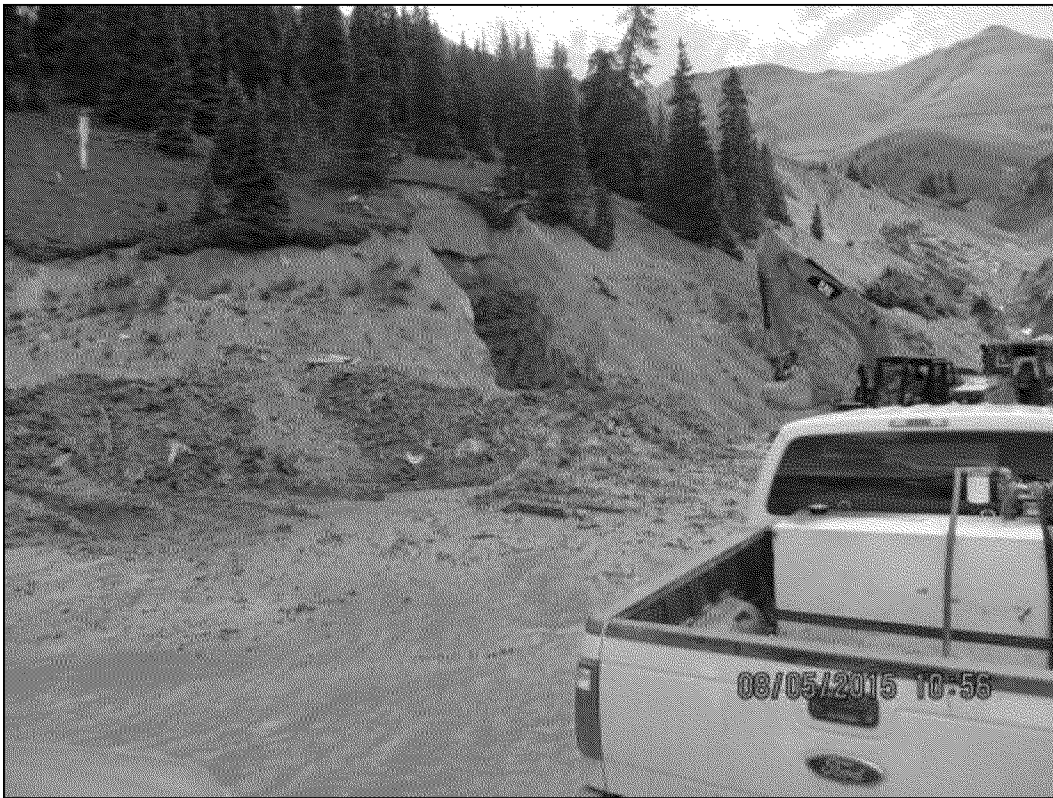
Figure 53.—Photograph showing the blowout at 10:56 a.m. on August 5, 2015 (photograph from EPA project files).

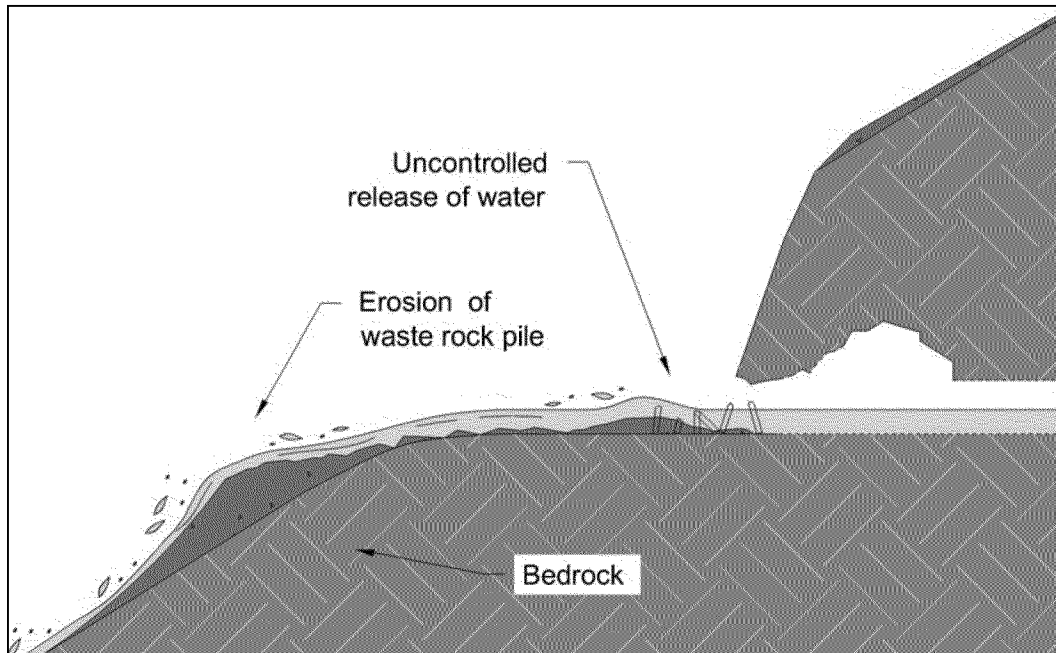
Figure 55.—Cross-section showing the blowout as it eroded the blockage and eroded fill from the waste-rock dump (not to scale).

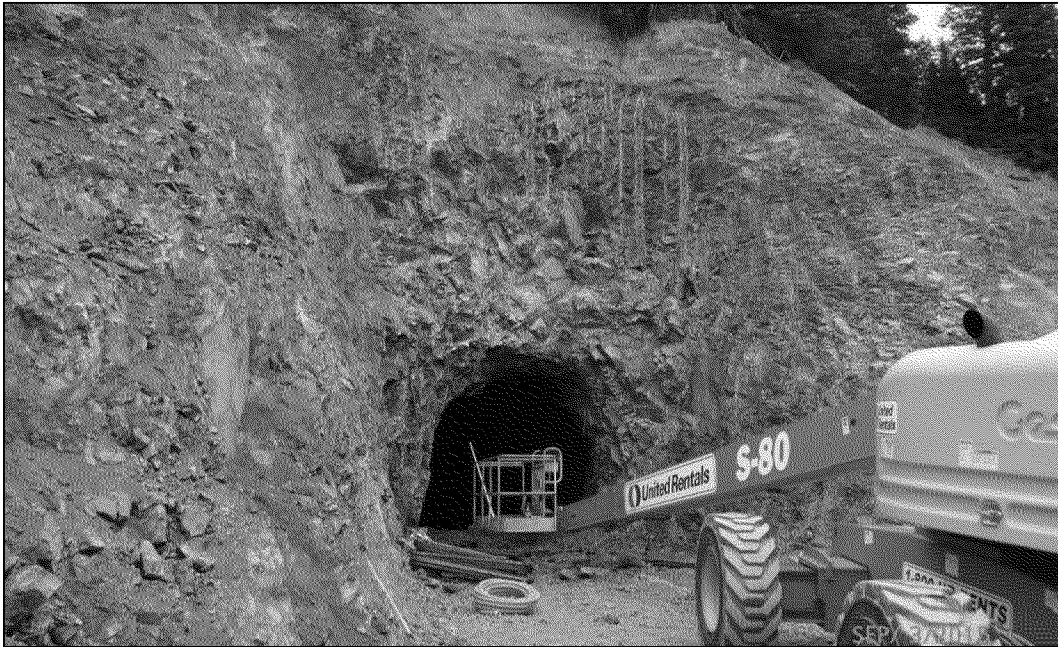
Figure 64.—Photograph showing the adit on September 3, 2015, at the initiation of rock bolting. The rock had been excavated to provide a larger work area. Note the excavator teeth marks left in the rock, an indication that the rock is altered and contains a significant amount of clay.
